NASA CR-121125  
MDC G4328

# CONTAMINATION AVOIDANCE DEVICES FOR POPPET-TYPE SHUTOFF VALVES

FINAL REPORT

January 1973

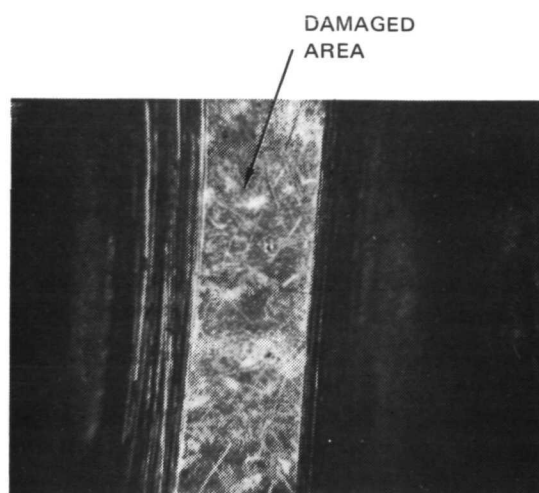
Figure 3-5. Microphotograph of -1 Valve Seat (A286) Damage (60X)

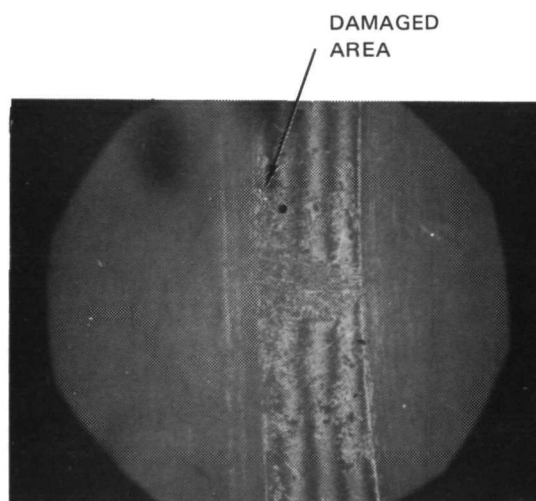
Figure 3-6. Interferometer Photo of Damaged Area of -1 Valve Seat (A286) (60X)

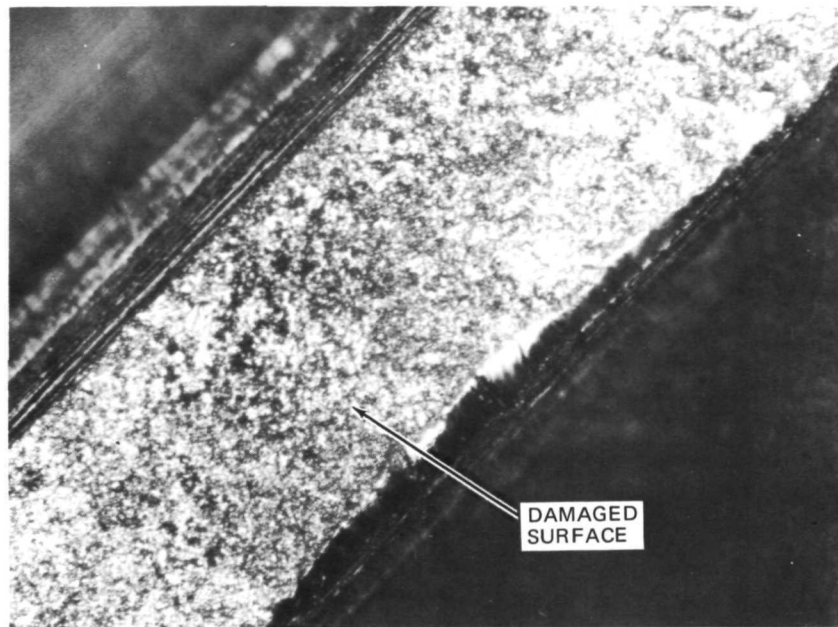
Figure 3-15. -1 A286 Seat after 40,000 Cycles on Test No. 1 - Typical Damage (160X)

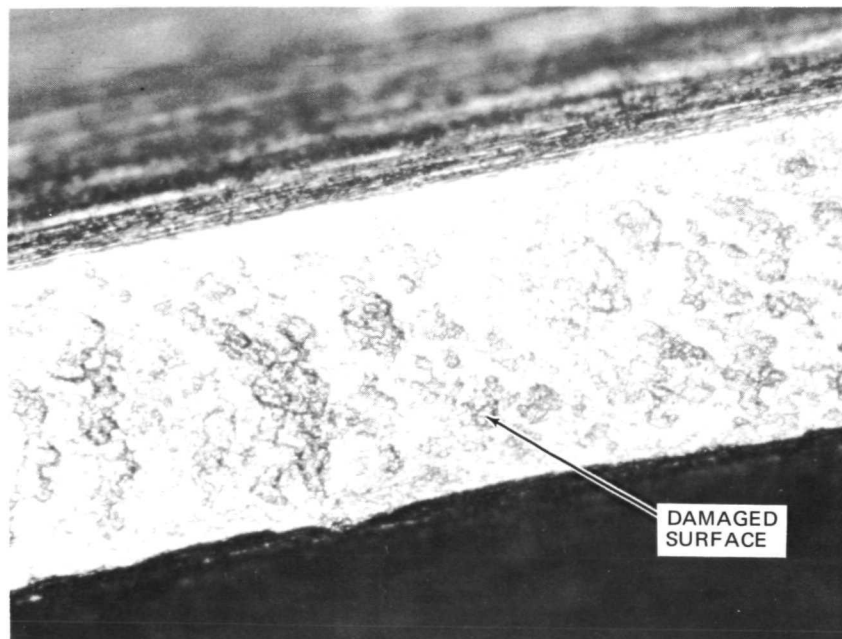
Figure 3-16. -1 A286 Seat after 40,000 Cycles on Test No. 1 - Area of Severe Damage (160X)

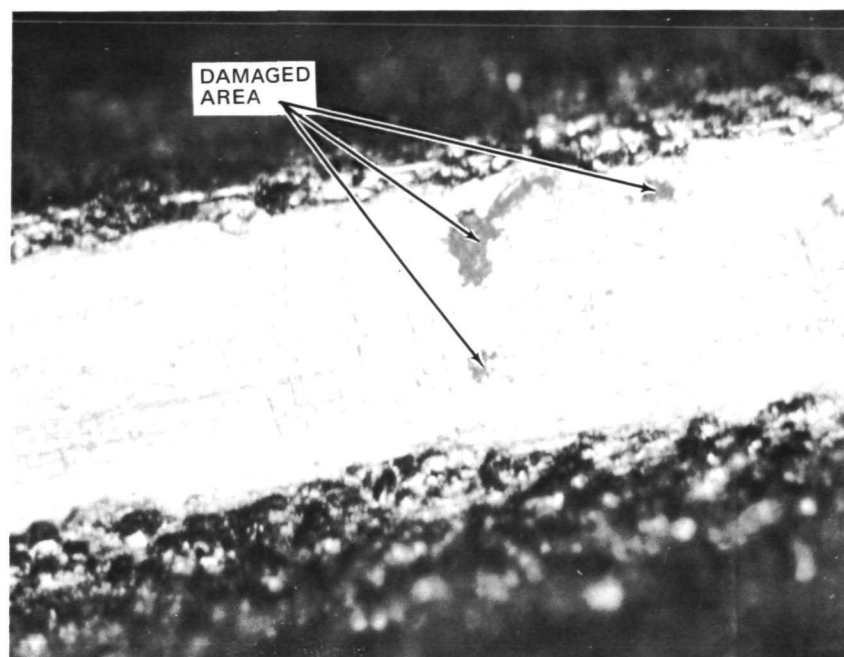
The first 100,000 cycle-life tests of the -501 valve were completed with no significant change in the measured internal leakage rate. The small change measured would indicate that the valve was improving through the testing and was actually leaking at a lower rate at the end of 100,000 cycles as compared to the start of the test program. The -501 valve was removed from the stand at the completion of cycle test No. 2 and the 77°K (-320°F) leakage test was performed. The thermal stabilization was considerably better on the post-test 77°K (-320°F) leakage tests than on the pretest leakage tests, and the post-test figure of 5.32 SCCM at  $7 \times 10^5$  N/m<sup>2</sup> (-100 psig) was in good analytical agreement with the post-test ambient leakage test data.

Figure 3-17. -501 Gold Plated Seat after 100,000 Cycles on Test No. 2 (160X)

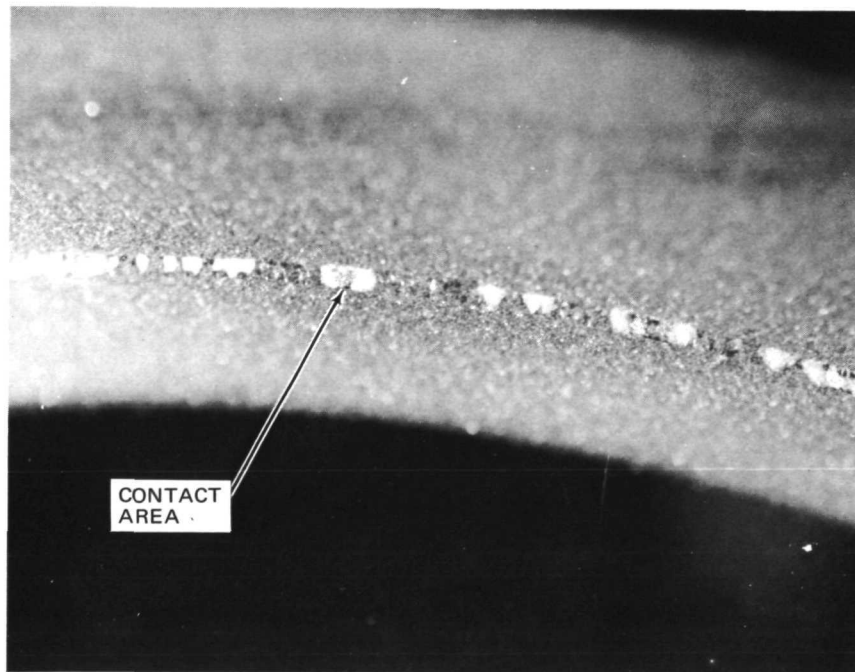
Figure 3-18. -1 Poppet after 16,200 Cycles on Test No. 3 (20X)

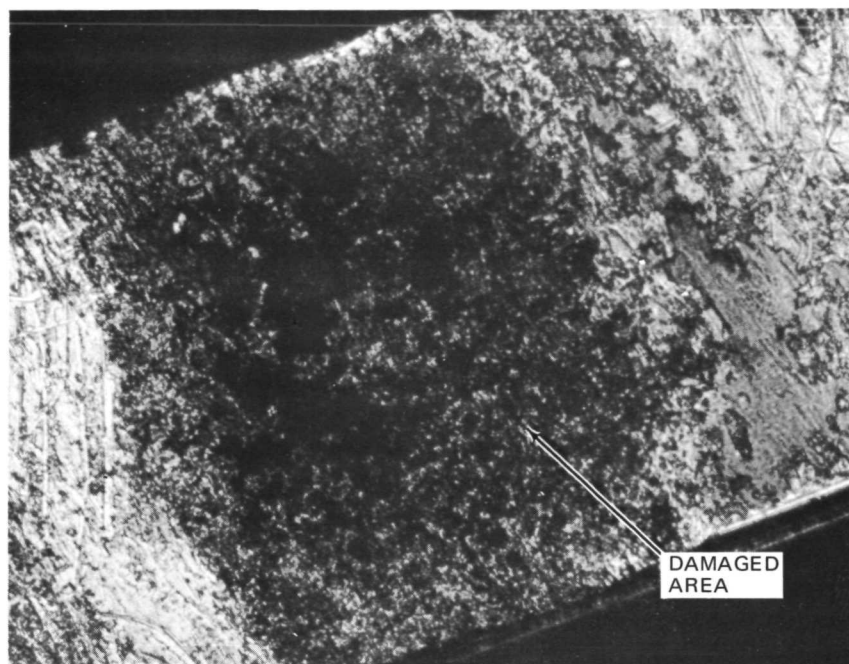
Figure 3-19. -1 (A286) Seat after 16,200 Cycles on Test No. 3 – Area of Severe Damage (160X)

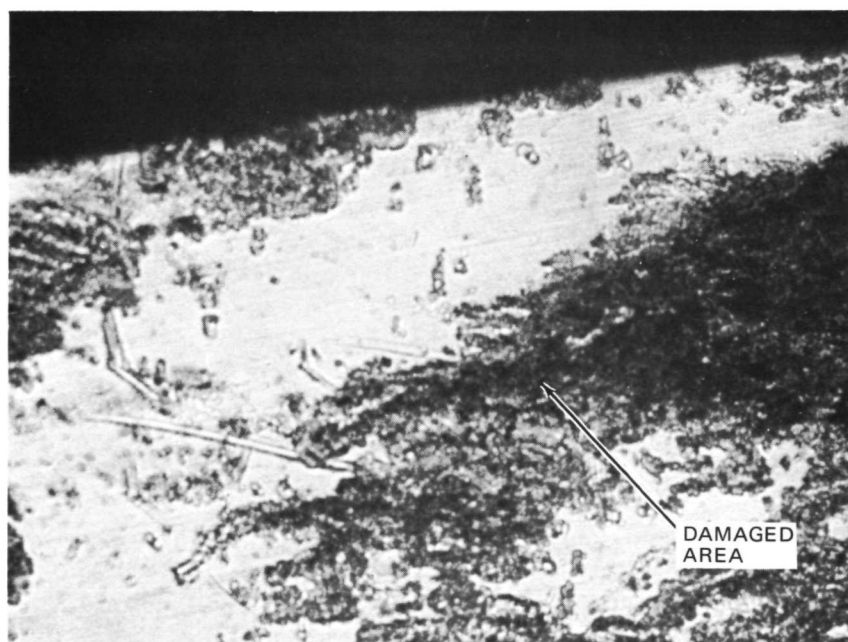
Figure 3-20. -1 (A286) Seat after 16,200 Cycles on Test No. 3-Area of Moderate Damage (160X)

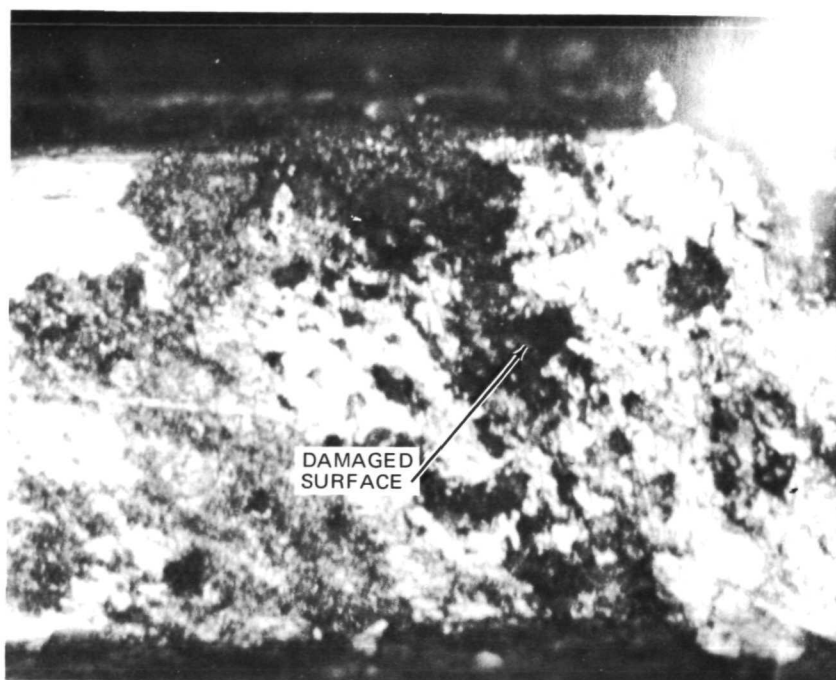
The measured leakage rates and visual inspection indicates that the seat failure observed in Test No. 4 consisted of two entirely different failure modes. It appears that from the first cycle to the 47,500 cycle point a

Figure 3-21. -501 Gold-Plated Seat after 56,000 Cycles on Test No. 4-Area of Severe Damage (160X)

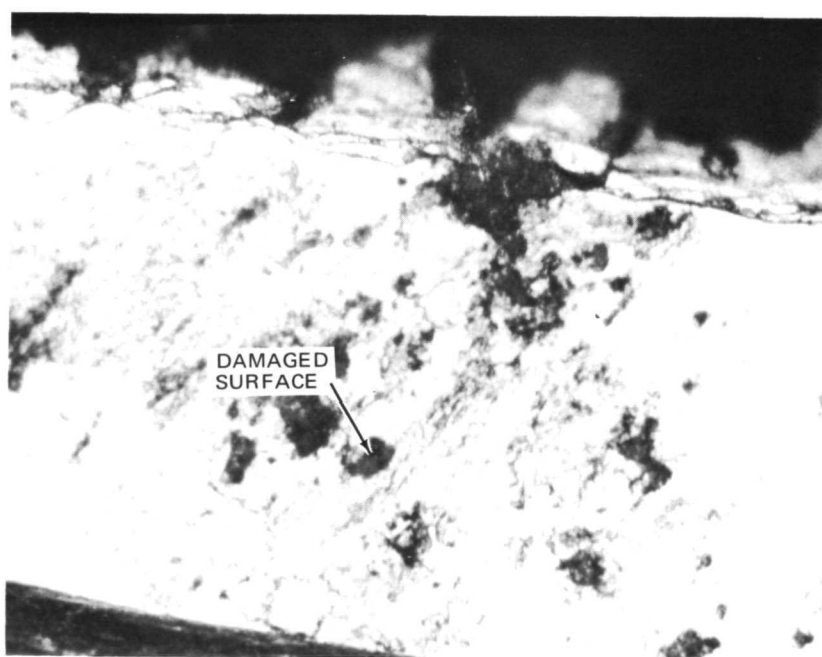
Figure 3-22. -501 Gold-Plated Seat after 56,000 Cycles on Test No. 4-Area of Moderate Damage (160X)

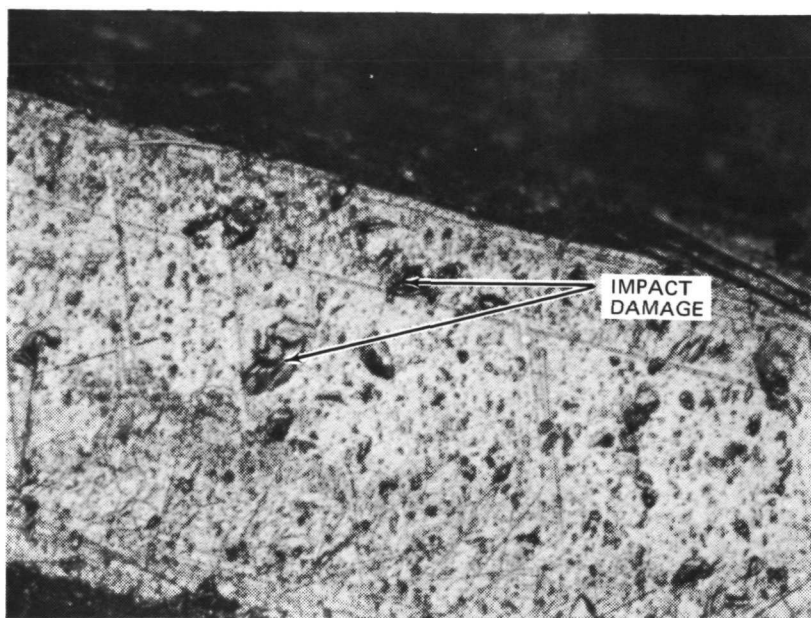
Figure 3-31. -501 Valve (Hard Gold-Plated) Seat Sealing Surface after First Contamination Test (160X)

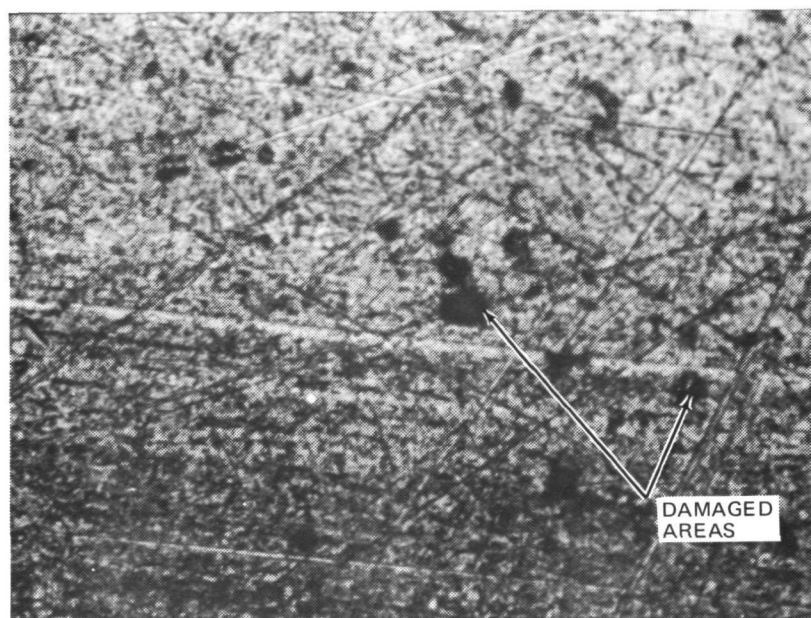
Figure 3-32. -501 Valve Bumper Surface after First Contamination Test (160X)

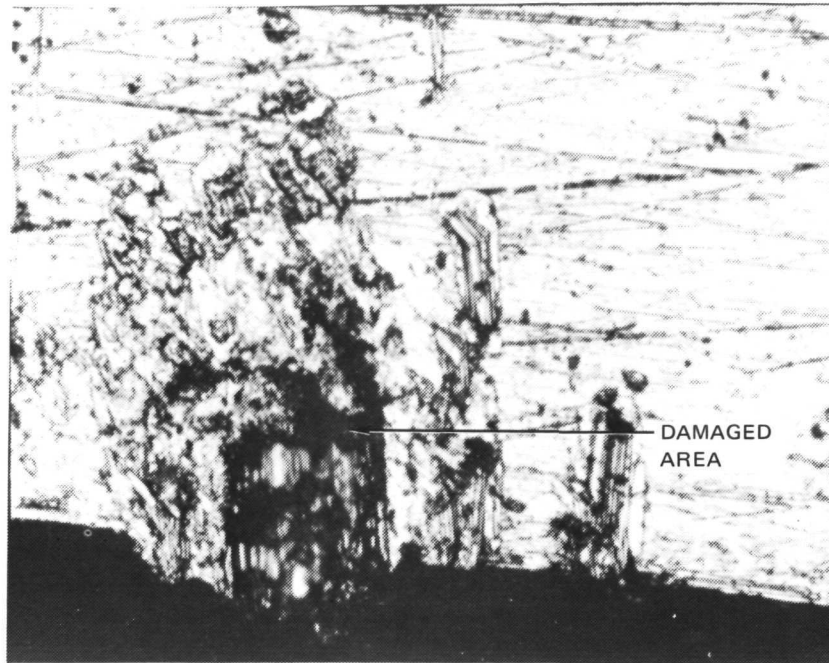
Figure 3-36. Contamination Damage on Gold Plated Seat (75–250 $\mu$  Particles in LN<sub>2</sub>) (250X)

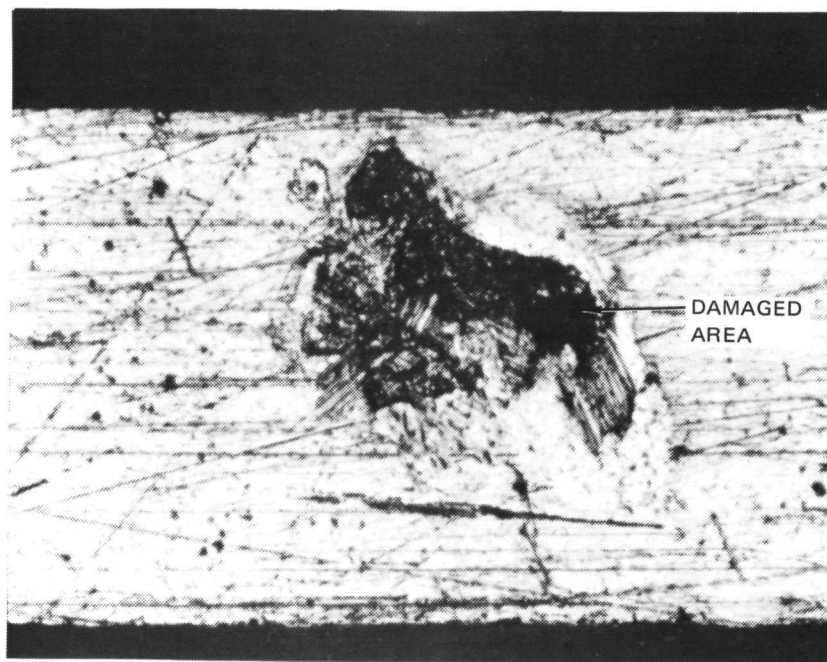
Figure 3-37. Contamination Damage on Gold Plated Seat (75–250 $\mu$  Particles in LN<sub>2</sub>) (250X)

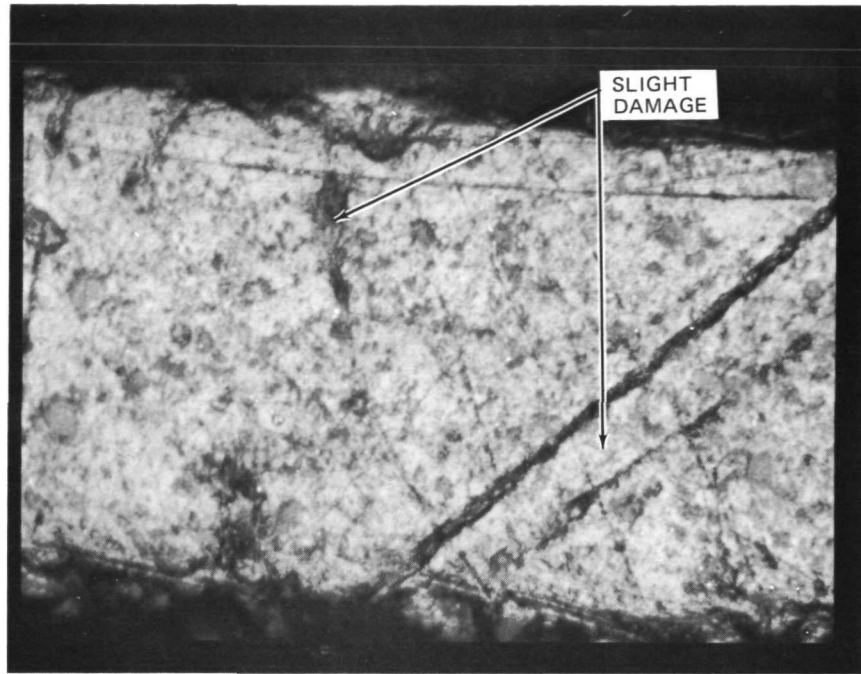
Figure 3-38. Typical Damage to Teflon S Coated Seat on Test No. 8 -  $\text{LN}_2$  (75-250 $\mu$ ) (160X)

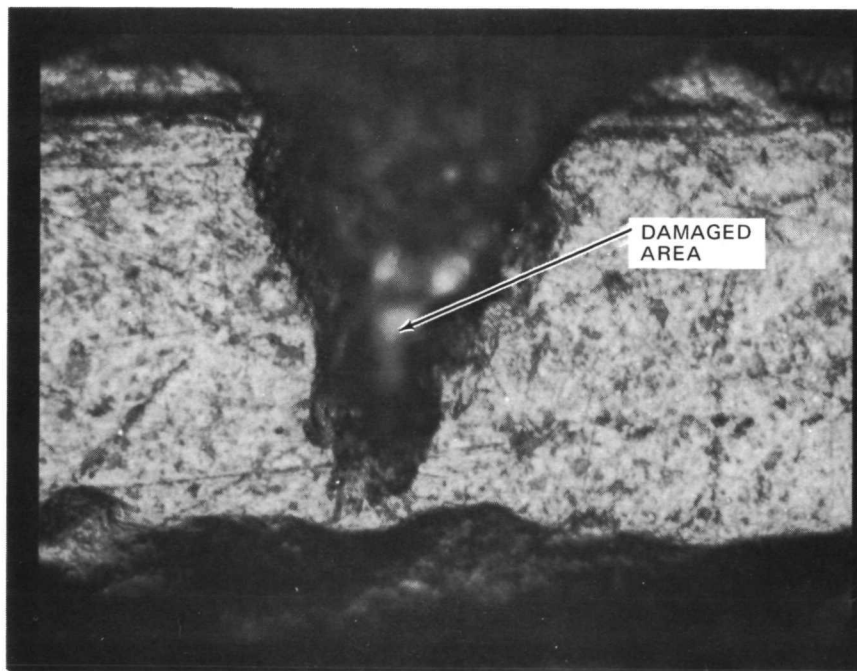
Figure 3-39. Chipped Area of Teflon S Coated Seat on Test No. 8 (160X)

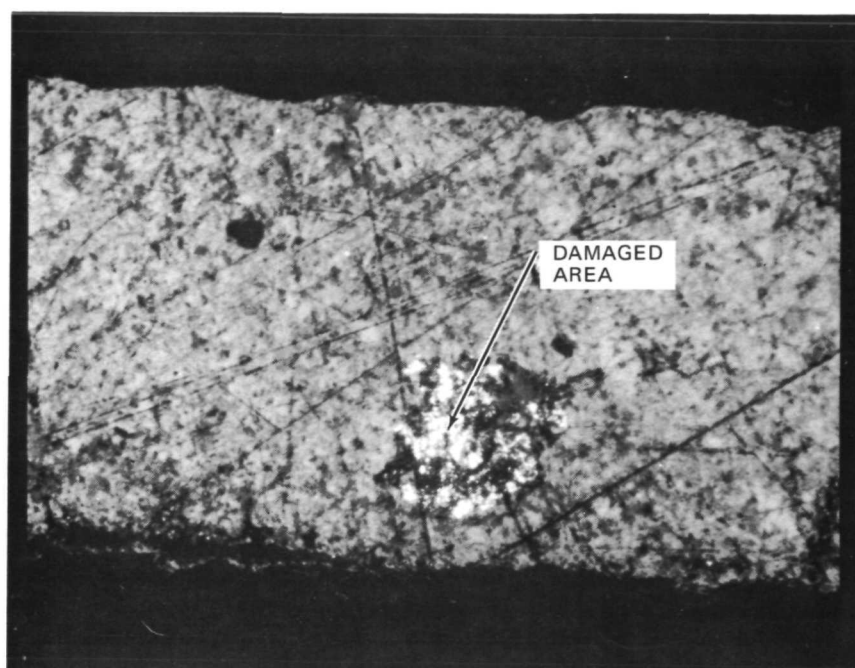
Figure 3-40. -503 Valve (Teflon S Coated) Seat Surface with Large Damage Area on Test No. 9 (160X)

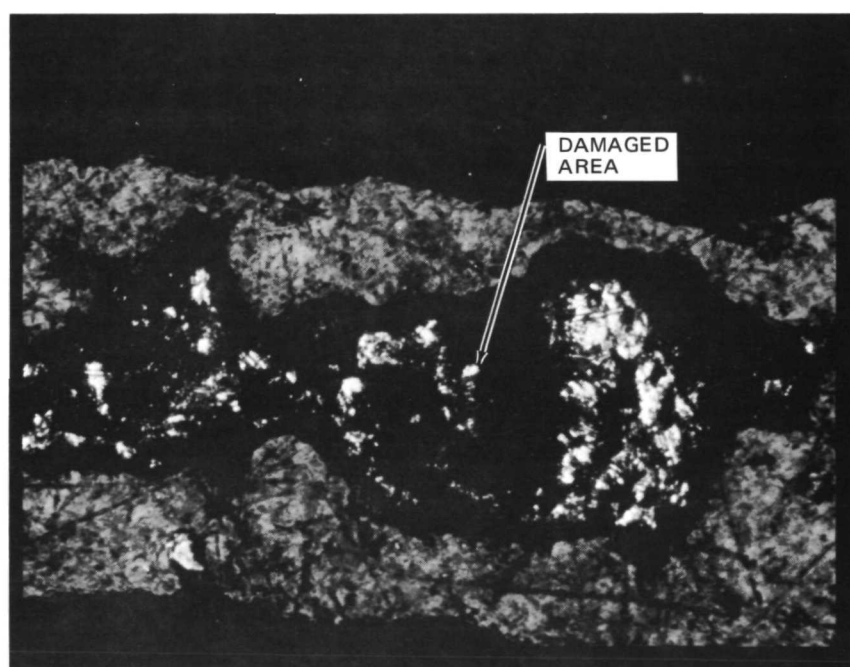
Figure 3-41. -503 Valve (Teflon S Coated) Seat Surface with Channel Erosion on Test No. 9 (160X)

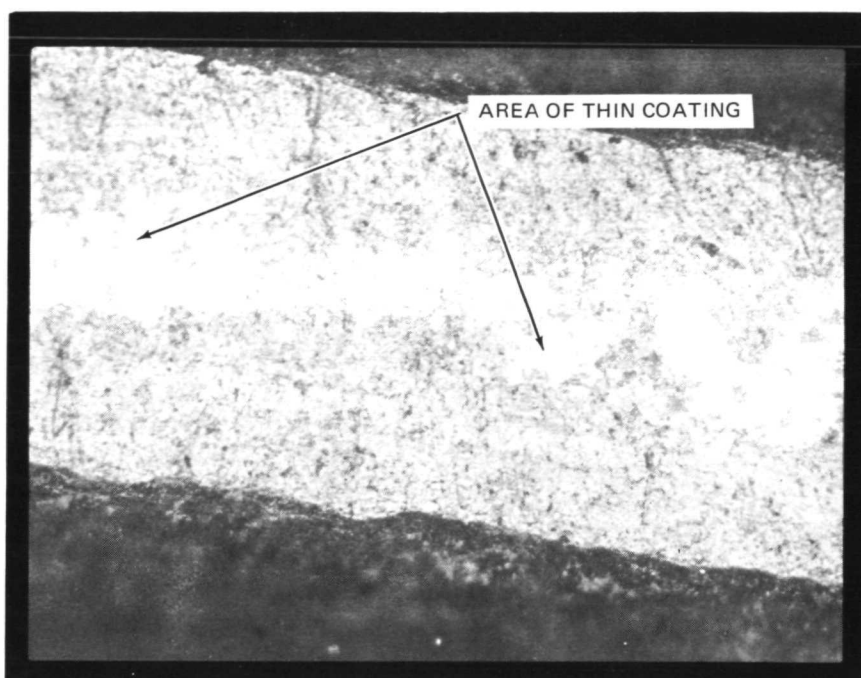
Figure 3-43. -503 Valve (Teflon S Coated) Seat Surface with Areas of Thin Coating - Pretest for Test No. 10 (160X)

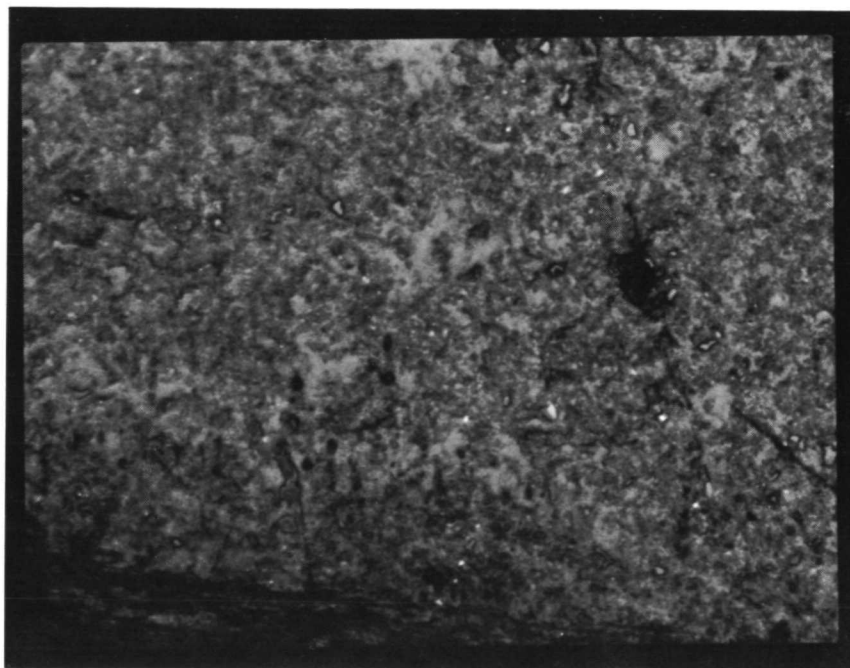
Figure 3-44. -503 Valve (Teflon S Coated) Seat Surface after Test No. 10 - Without Damage (160X)

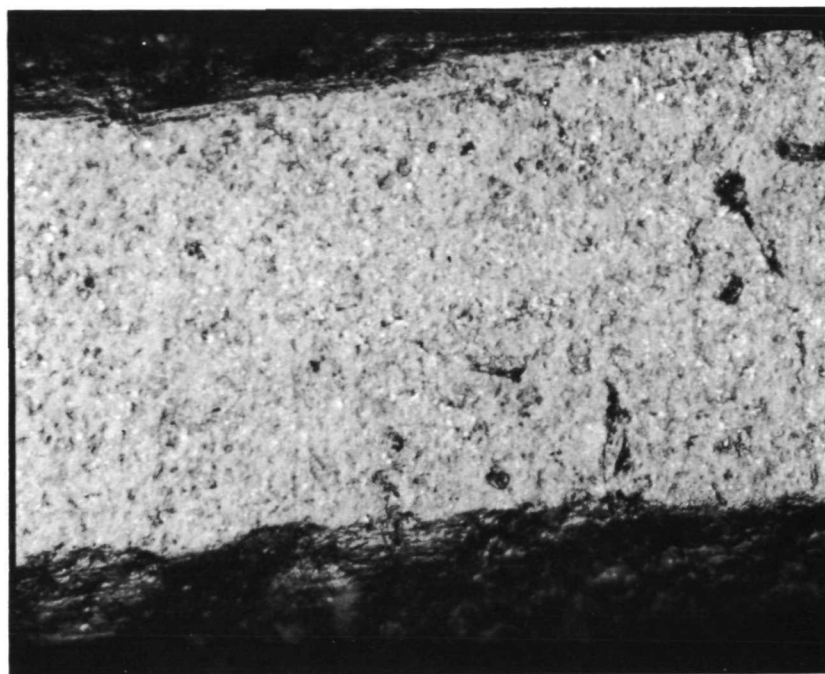
Figure 3-45. -501 Valve (Teflon S Coated) Seat Surface after Test No. 11 - Without Damage (160X)

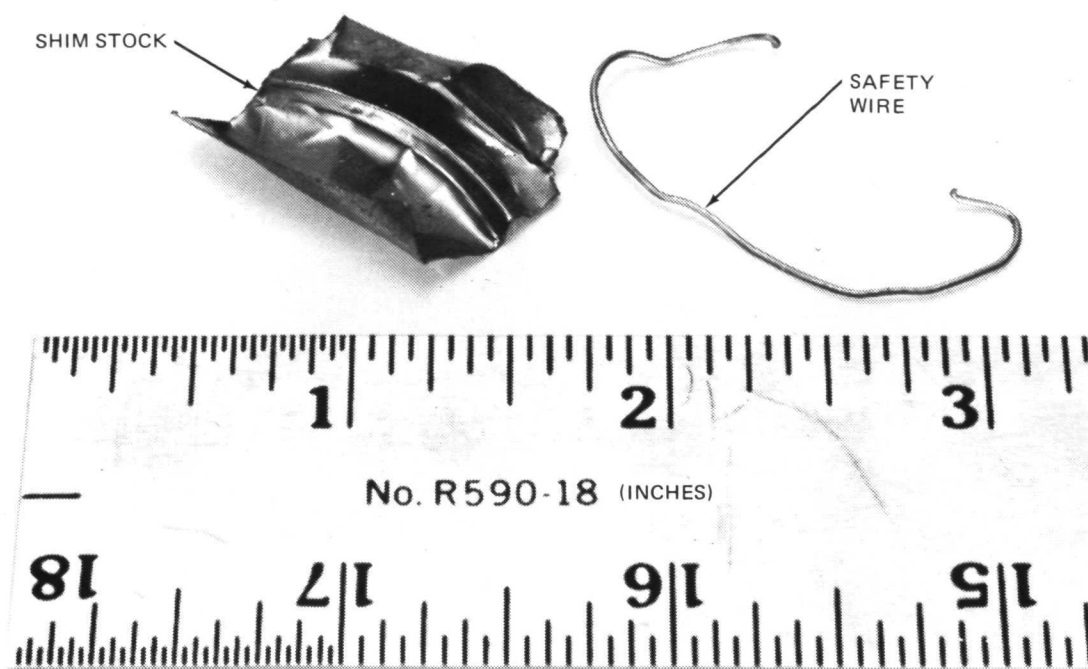
Figure 3-57. Uncontrolled Contamination on Test No. 2
